**PHASE 1 ENVIRONMENTAL SITE
ASSESSMENT, BLOCK 1, SECTION 7,
REID AND BLOCK 1, SECTION 52 AND
BLOCK 1, 3, 4, 7, SECTION 57, BRADDON,
ACT**

Report Date: 16 June 2010
Project Ref: ENVICANB00347AA

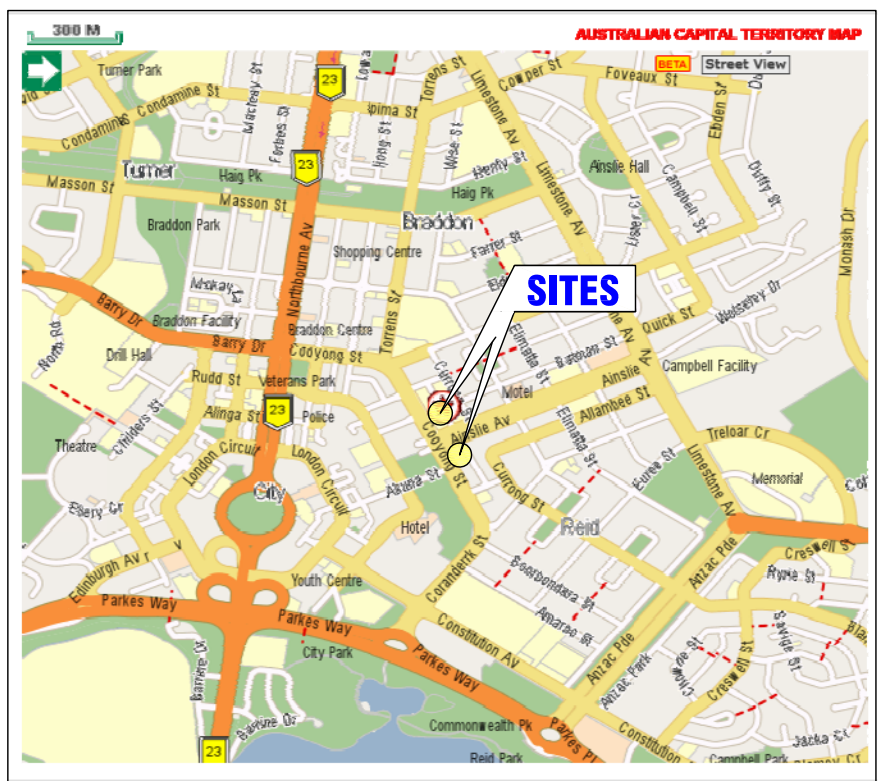
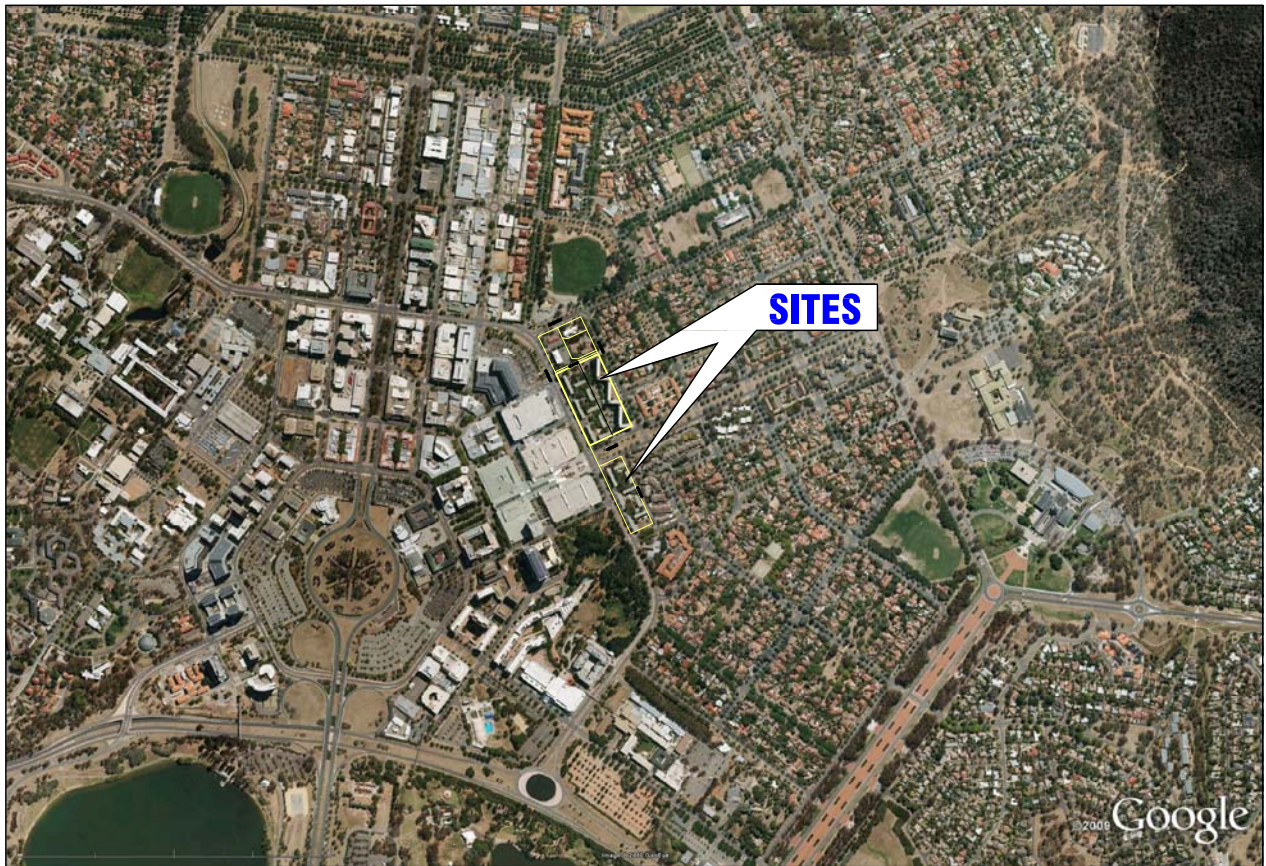
coffey environments SPECIALISTS IN ENVIRONMENTAL, SOCIAL AND SAFETY PERFORMANCE	client:	PURDON ASSOCIATES		
approved			project:	PHASE 1 ENVIRONMENTAL SITE ASSESSMENT BLOCK 1, SECTION 7, REID, BLOCK 1, SECTION 52 & BLOCKS 1, 3, 4 & 7, SECTION 57, BRADDON, ACT		
date	09.06.2010		title:	SITE LOCALITY PLAN		
scale	AS SHOWN		project no:	ENVICANB00347AA-D01	figure no:	FIGURE 1
original size	A4

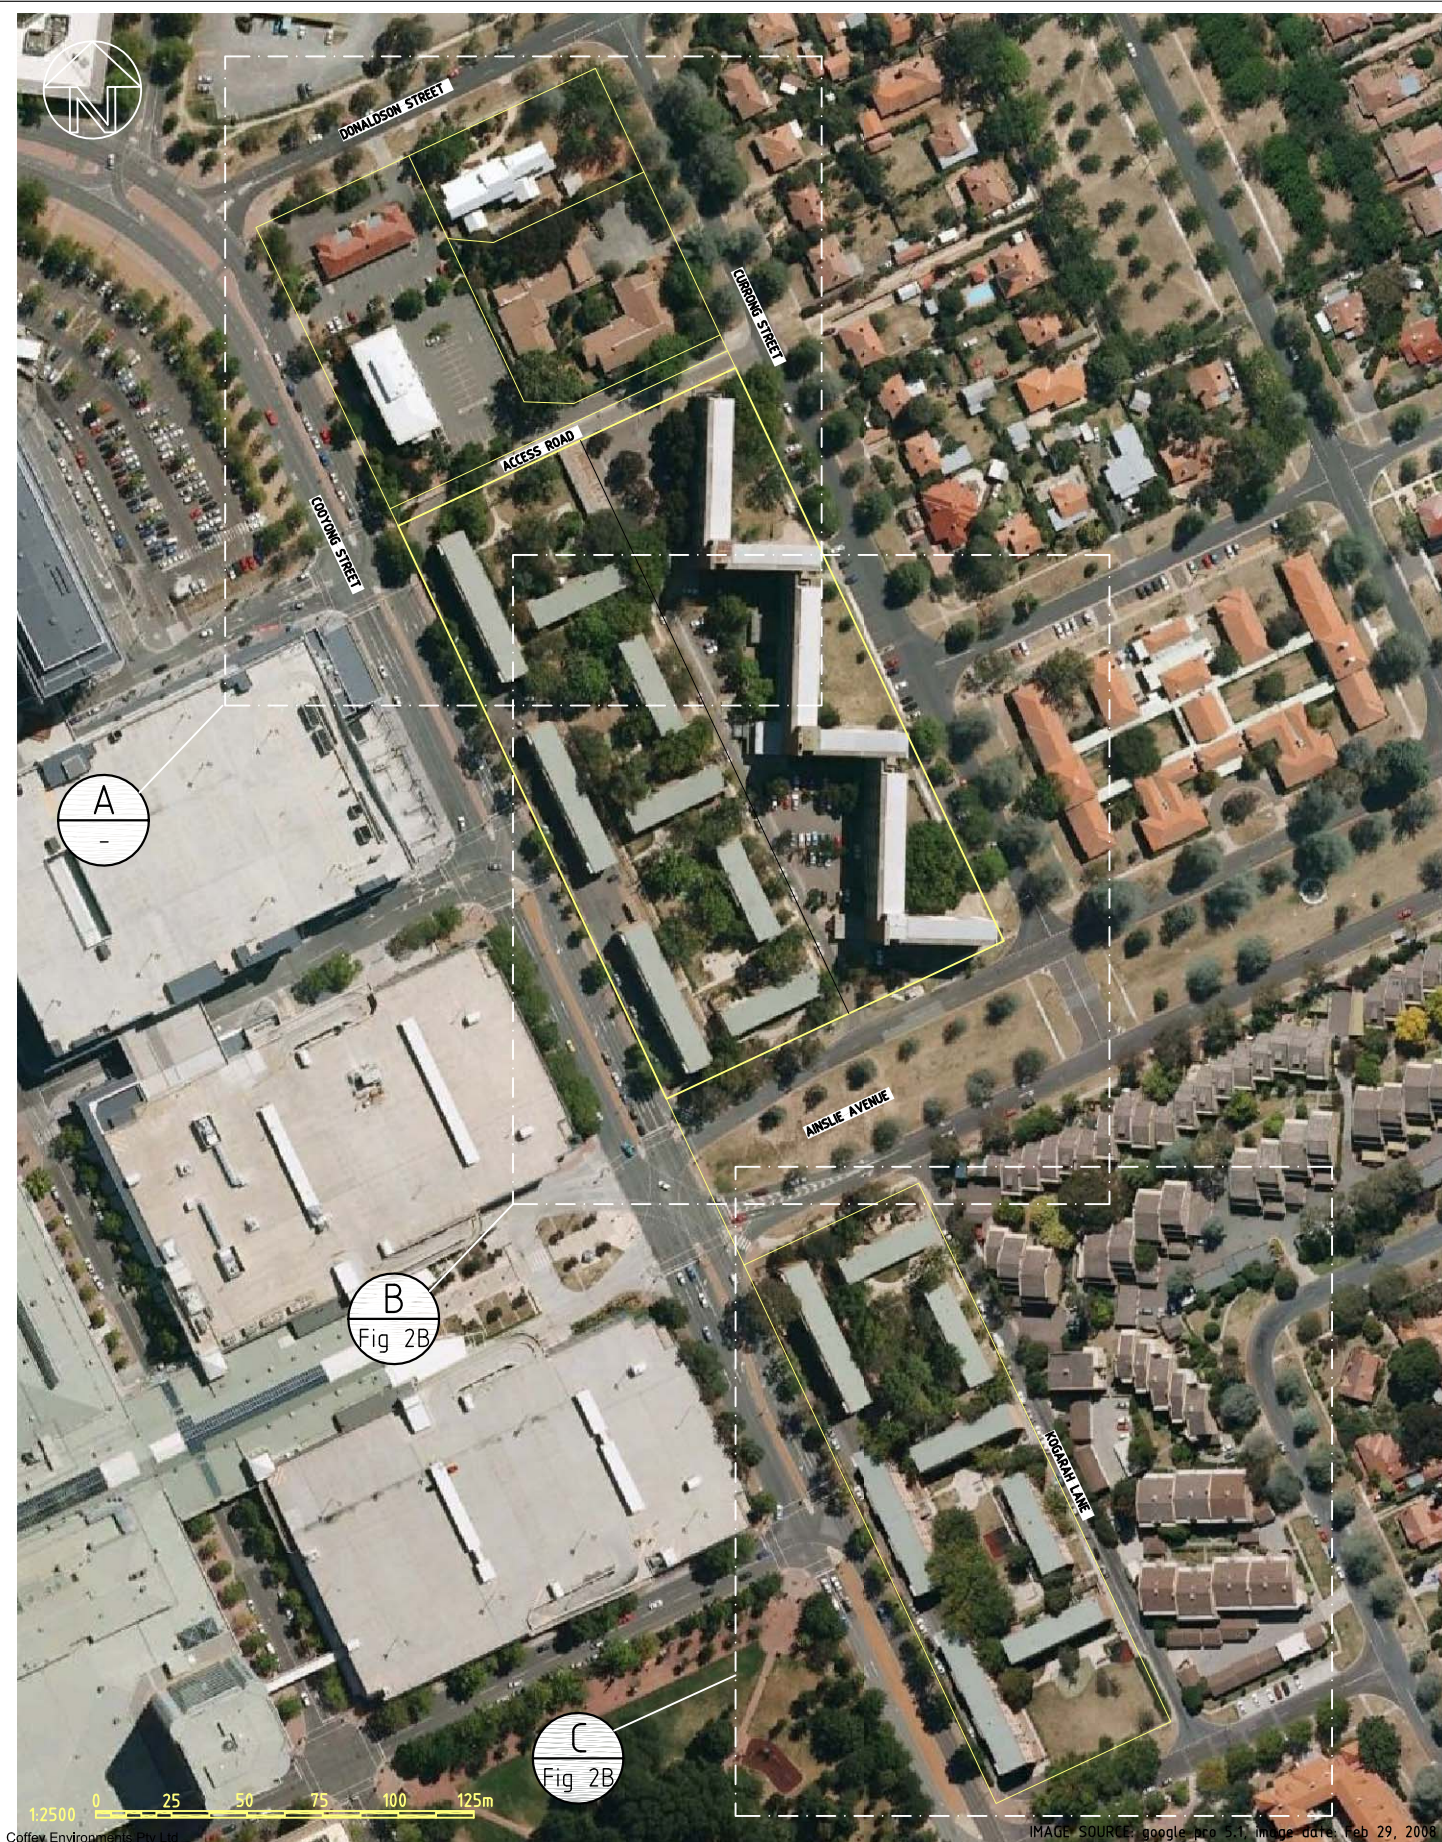
client:	PURDON ASSOCIATES
project:	PHASE 1 ENVIRONMENTAL SITE ASSESSMENT BLOCK 1, SECTION 7, REID, BLOCK 1, SECTION 52 & BLOCKS 1, 3, 4 & 7, SECTION 57, BRADDON, ACT
title:	SITE LAYOUT PLAN - NORTH
project no:	ENVICANB00347AA-D01
figure no:	FIGURE 2A

Figure 2A: Site Layout for Blocks 1, 3, 4, 7 Section 57 and Block 1 Section 52
